WORKSHOP MANUAL
TRACTOR

**L3240, L3540, L4240,
L5240, L5740**

Kubota

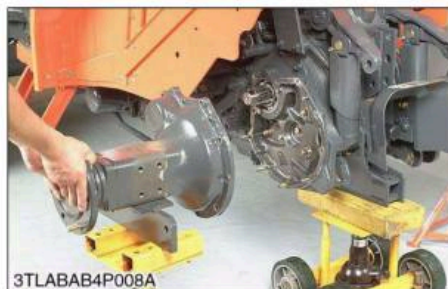
Rear Axle Case

1. Disconnect the brake rod.
2. Place the disassembling stand under the rear axle case.
3. Remove the rear axle mounting screws and nuts.
4. Separate the rear axle case from brake case.

- Apply liquid gasket (Three Bond 1208D or equivalent) to joint face of the rear axle case and brake case.

Tightening torque	Rear axle case mounting screw and nut	M10 screw	48 to 55 N·m 4.9 to 5.7 kgf·m 36 to 41 lbf·ft
		M10 nut (9T) (Except L3240, L3540)	61 to 70 N·m 6.2 to 7.2 kgf·m 45 to 52 lbf·ft
		M12 screw (Except L3240, L3540)	78 to 90 N·m 7.9 to 9.2 kgf·m 58 to 66 lbf·ft
