WORKSHOP MANUAL  
**TRACTOR**

**L4400HST  
(SUPPLEMENT)**

**Kubota**

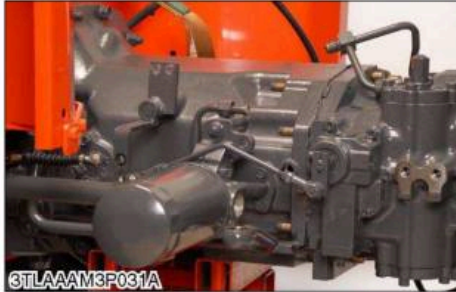
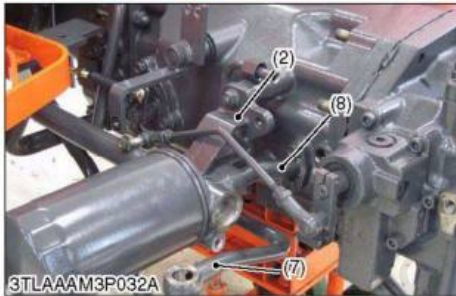
**Hydraulic Filter Bracket and HST Charge Pump Pipe**

1. Disconnect the HST pipe (4).
2. Disconnect the HST pedal rod (5).
3. Remove the suction pipe (1).
4. Disconnect the delivery pipe (7).
5. Remove the hydraulic filter bracket (2) from the mid case.
6. Place the disassembling stand under the mid case.
7. Remove the HST charge pump pipe (8) from the mid case.
8. Remove the HST regulator valve delivery pipe (9).
9. Remove the PTO clutch delivery pipe (10).
10. Hoist the HST housing case with the nylon sling.
11. Remove the HST housing case and the mid case mounting nuts.

Tightening torque	HST housing case and mid case mounting nut	77.5 to 90.2 N·m 7.9 to 9.2 kgf·m 57.1 to 66.5 lbf·ft
-------------------	--	---

- |                              |                                       |

| (1) Suction Pipe | (6) Hydraulic Filter Cartridge |
| (2) Hydraulic Filter Bracket | (7) Delivery Pipe |
| (3) Mid Case | (8) HST Charge Pump Pipe |
| (4) HST Pipe | (9) HST Regulator Valve Delivery Pipe |
| (5) HST Pedal Rod | (10) PTO Clutch Delivery Pipe |
