WORKSHOP MANUAL
TRACTOR

**L3240, L3540, L4240,
L5240, L5740**

Kubota

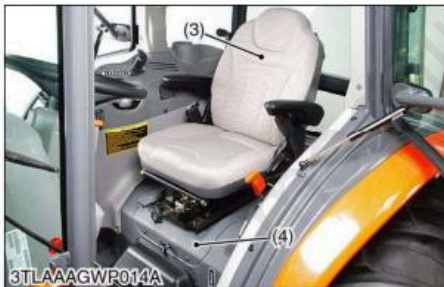
Clutch Rod, Brake Pedal Rod and Electric Wiring

1. Disconnect the brake pedal rod (6) and clutch rod (4).
2. Disconnect the wiring connectors for alternator (1), coolant temperature sensor (9), oil pressure switch (2), fuel unit (3), starter motor (7) and battery.
3. Remove the clamps and ground cable of wiring harness and collect wiring harness to the step or cabin.
4. Remove the clamps (8) of A/C hoses (5).

- Be sure to check and adjust the clutch and brake pedal free travel. (Refer to "7. CHECK AND MAINTENANCE" at "G. GENERAL" section.)

| (1) Alternator | (6) Brake Pedal Rod |
| (2) Oil Pressure Switch | (7) Starter Motor |
| (3) Fuel Unit | (8) Clamps |
| (4) Clutch Rod | (9) Coolant Temperature Sensor |
| (5) A/C Hoses | |
