# Service Manual

**FC/MC, Chassis, Mast**

**FB30K**

**FB35K**

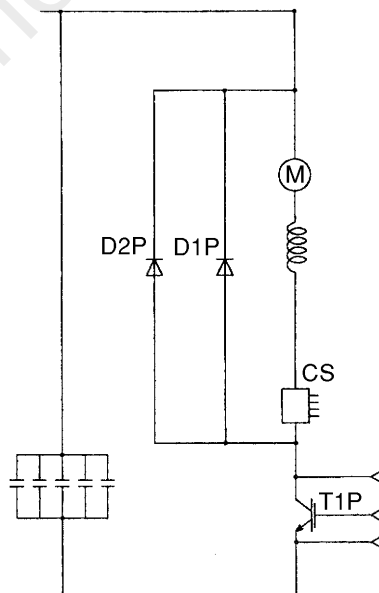
208296

**Problem: Pump Motor, Current Sensor Fault****Symptom:**

- (2) Wire break in pump T1P IGBT, faulty wire connection, drive card defect, pump CS current sensor failure, logic card defect.

- (3) Disconnect battery plug.

Check CS for abnormality.

- (4) Check IGBT and drive card for abnormality.

Replace logic card.

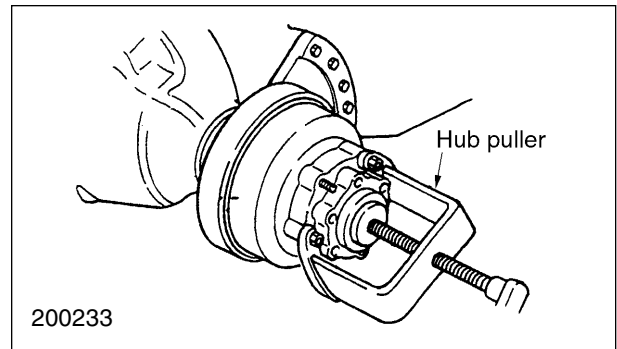
(4) Remove the hub and drum assembly.

The hub and drum assembly will be removed by pulling horizontally. If it cannot be pulled out, use the hub puller as shown in the illustration at right.

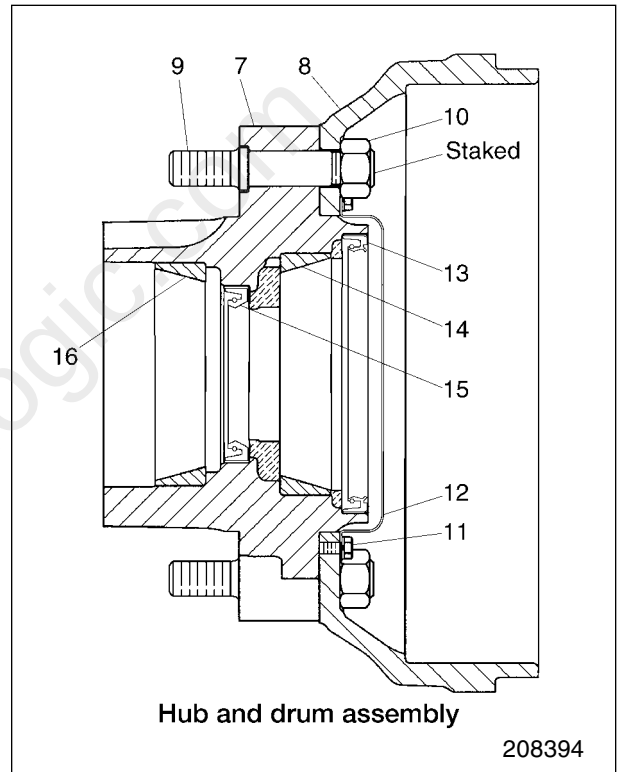
- Remove the oil deflector 12 if necessary.
- Do not remove the following parts from the inside of the wheel hub 7 unless they are faulty. When removing them, use a puller.
  - Taper roller bearing outer race 14 and 16
  - Oil seal 13 and 15
- Normally, it is not necessary to separate the wheel hub 7 and the brake drum 8. To separate them, the nut 10 must be removed. (The nut 10 has been staked to the bolt 9 after assembly to prevent dropping off.)

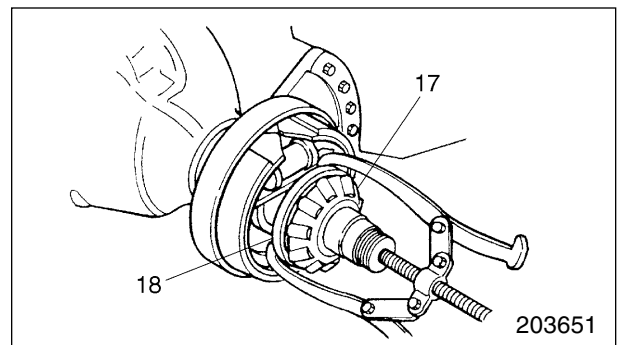
**3. Removal of seal retainer and bearing inner race**

Do not remove the retainer 18 and the bearing inner race 17 left on the axle housing unless they are faulty.

If they are to be replaced, remove them together using a puller.

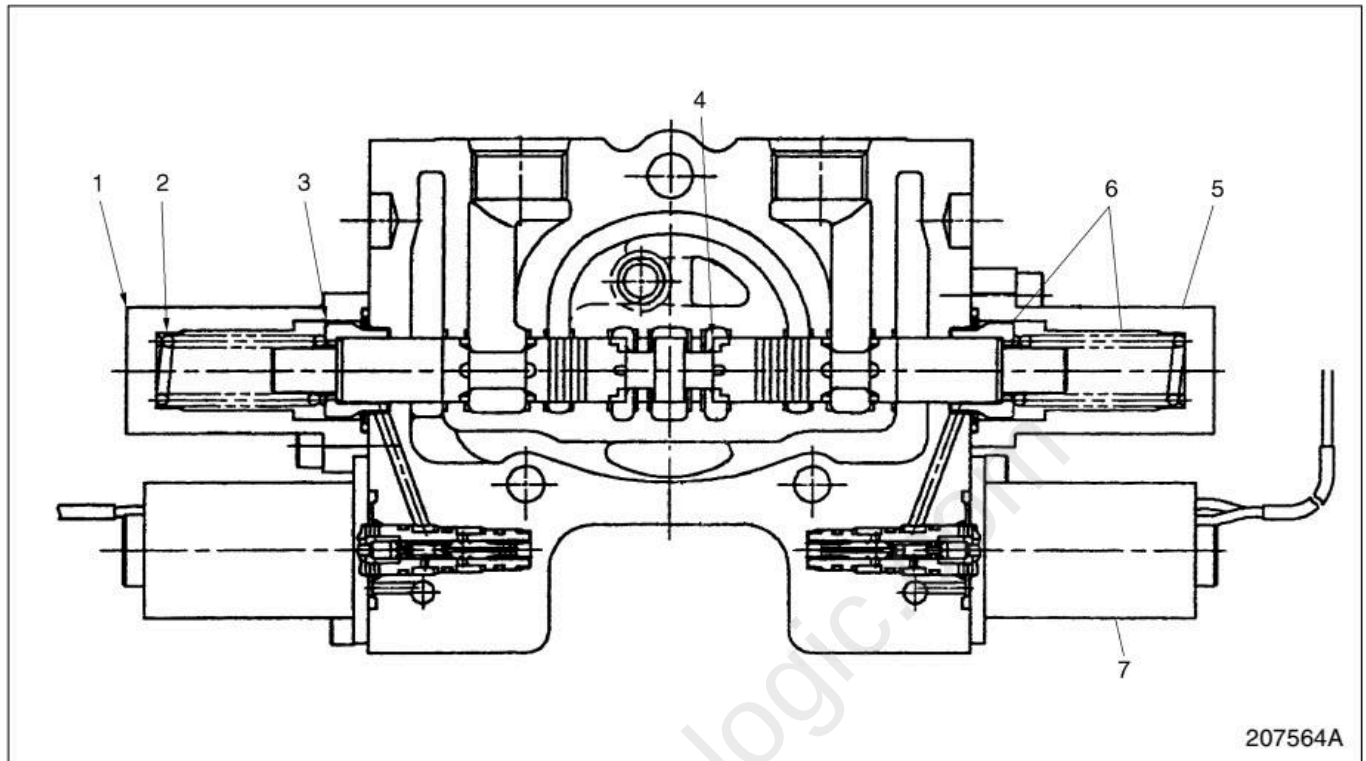
## Disassembly of Attachment Section Assembly

- 1 Cap, Socket-head bolt
- 2 Spring
- 3 Spring seat
- 4 Spool

- 5 Cap, Socket-head bolt
- 6 Spring, Spring seat
- 7 Proportional electromagnetic pressure control valve

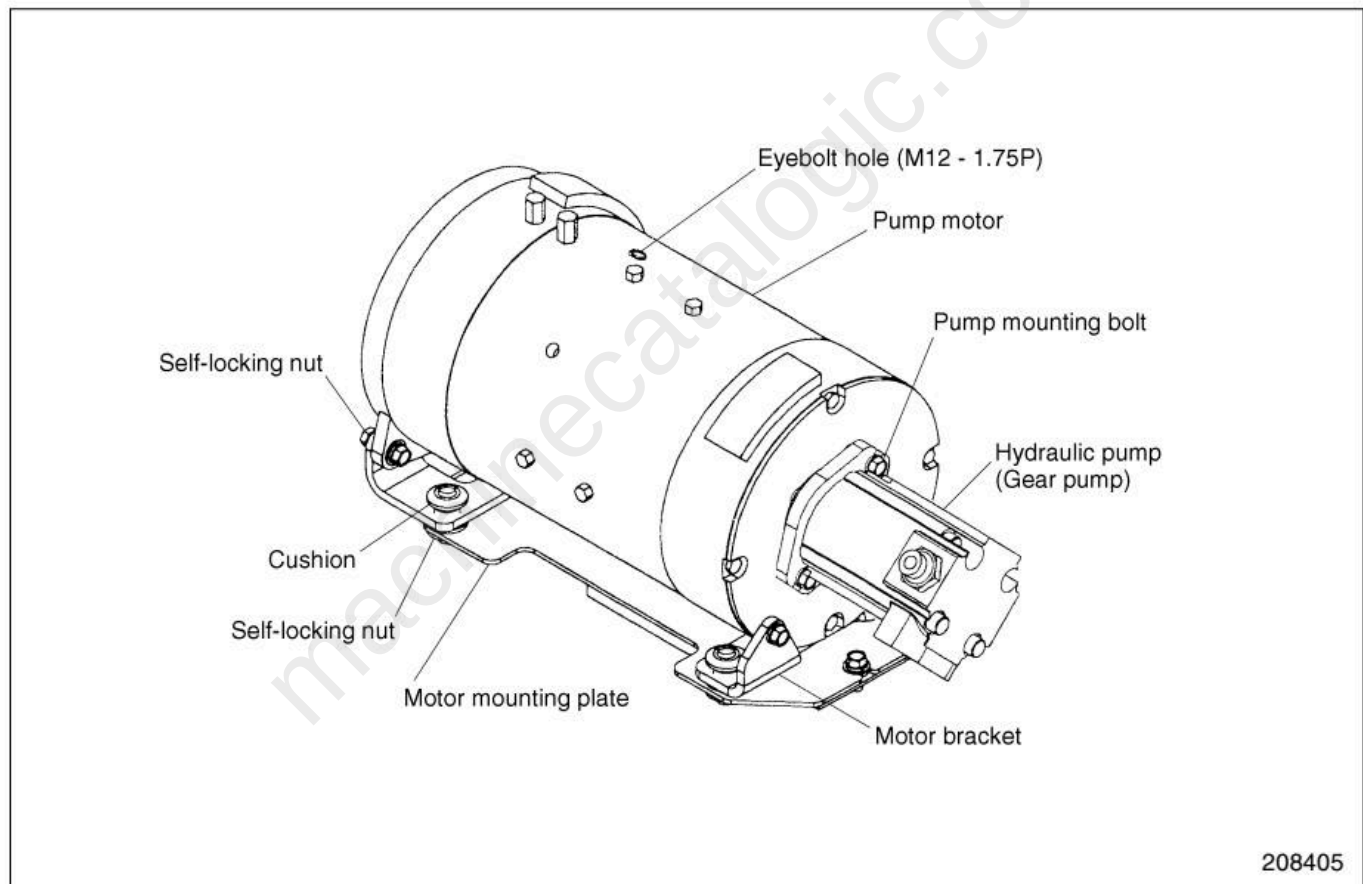
- (1) Draw out the pump motor from the vehicle with the motor mounting plate attached. (Refer to "Inspection of Brush for Wear and Brush Replacement" on page 6-5.)
- (2) When the motor is drawn out a little, install eyebolts (M12 - 1.75P) to the motor. Using the eyebolts, sling the motor and lower it to the ground. The motor weighs approximately 40 kg (88.2 lbs.).
- (3) Separate the pump motor, hydraulic pump, motor mounting plate, motor bracket, etc. from each other as shown.
