DIAGNOSIS MANUAL  
**COMMON RAIL SYSTEM**

**V6108-CR-TIE4**

## (10) Coolant Temperature Sensor Abnormality (DTC P0117 / 110-4, P0118 / 110-3)

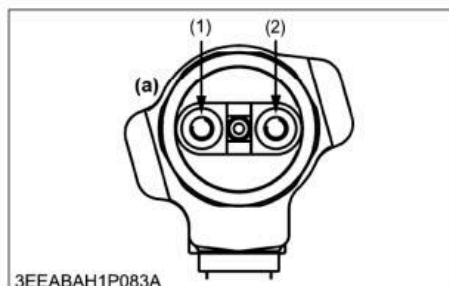
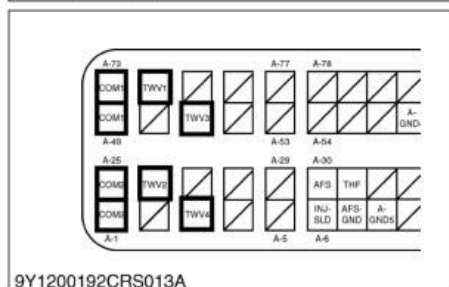
## 6. Check the Wiring Harness

Locate the cause of wiring harness ground short, and repair the faulty area.
