# Service Manual

## Chassis & Mast

### MC/FC

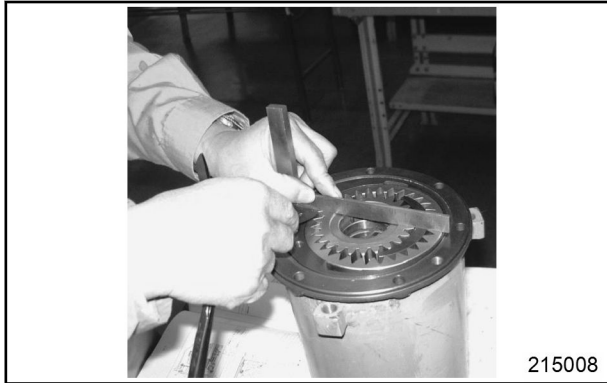
215008

- (3) Measure the clearance between torque converter housing (pump body) and drive gear using a feeler gauge.

| Internal gear and Drive gear | A | 0.040 to 0.083<br>(0.002 to 0.003) |
| | B | 0.15 (0.006) |

A: Standard value B: Repair or service limit  
Unit: mm (in.)
