# Service Manual

## Chassis & Mast

### MC/FC

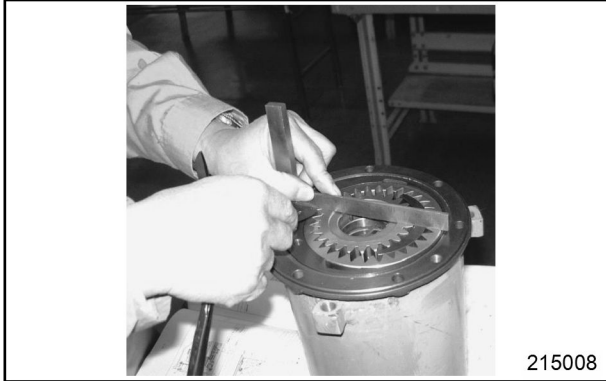
- (3) Measure the clearance between torque converter housing (pump body) and drive gear using a feeler gauge.

| Internal gear and Drive gear | A | 0.040 to 0.083<br>(0.002 to 0.003) |
| | B | 0.15 (0.006) |

A: Standard value B: Repair or service limit  
Unit: mm (in.)
