# iFLEX2 + iSCOUT expert compact

LMI system for  
Grove RT / TM

## Service Manual

**Issue 2/2008 Rev. C**

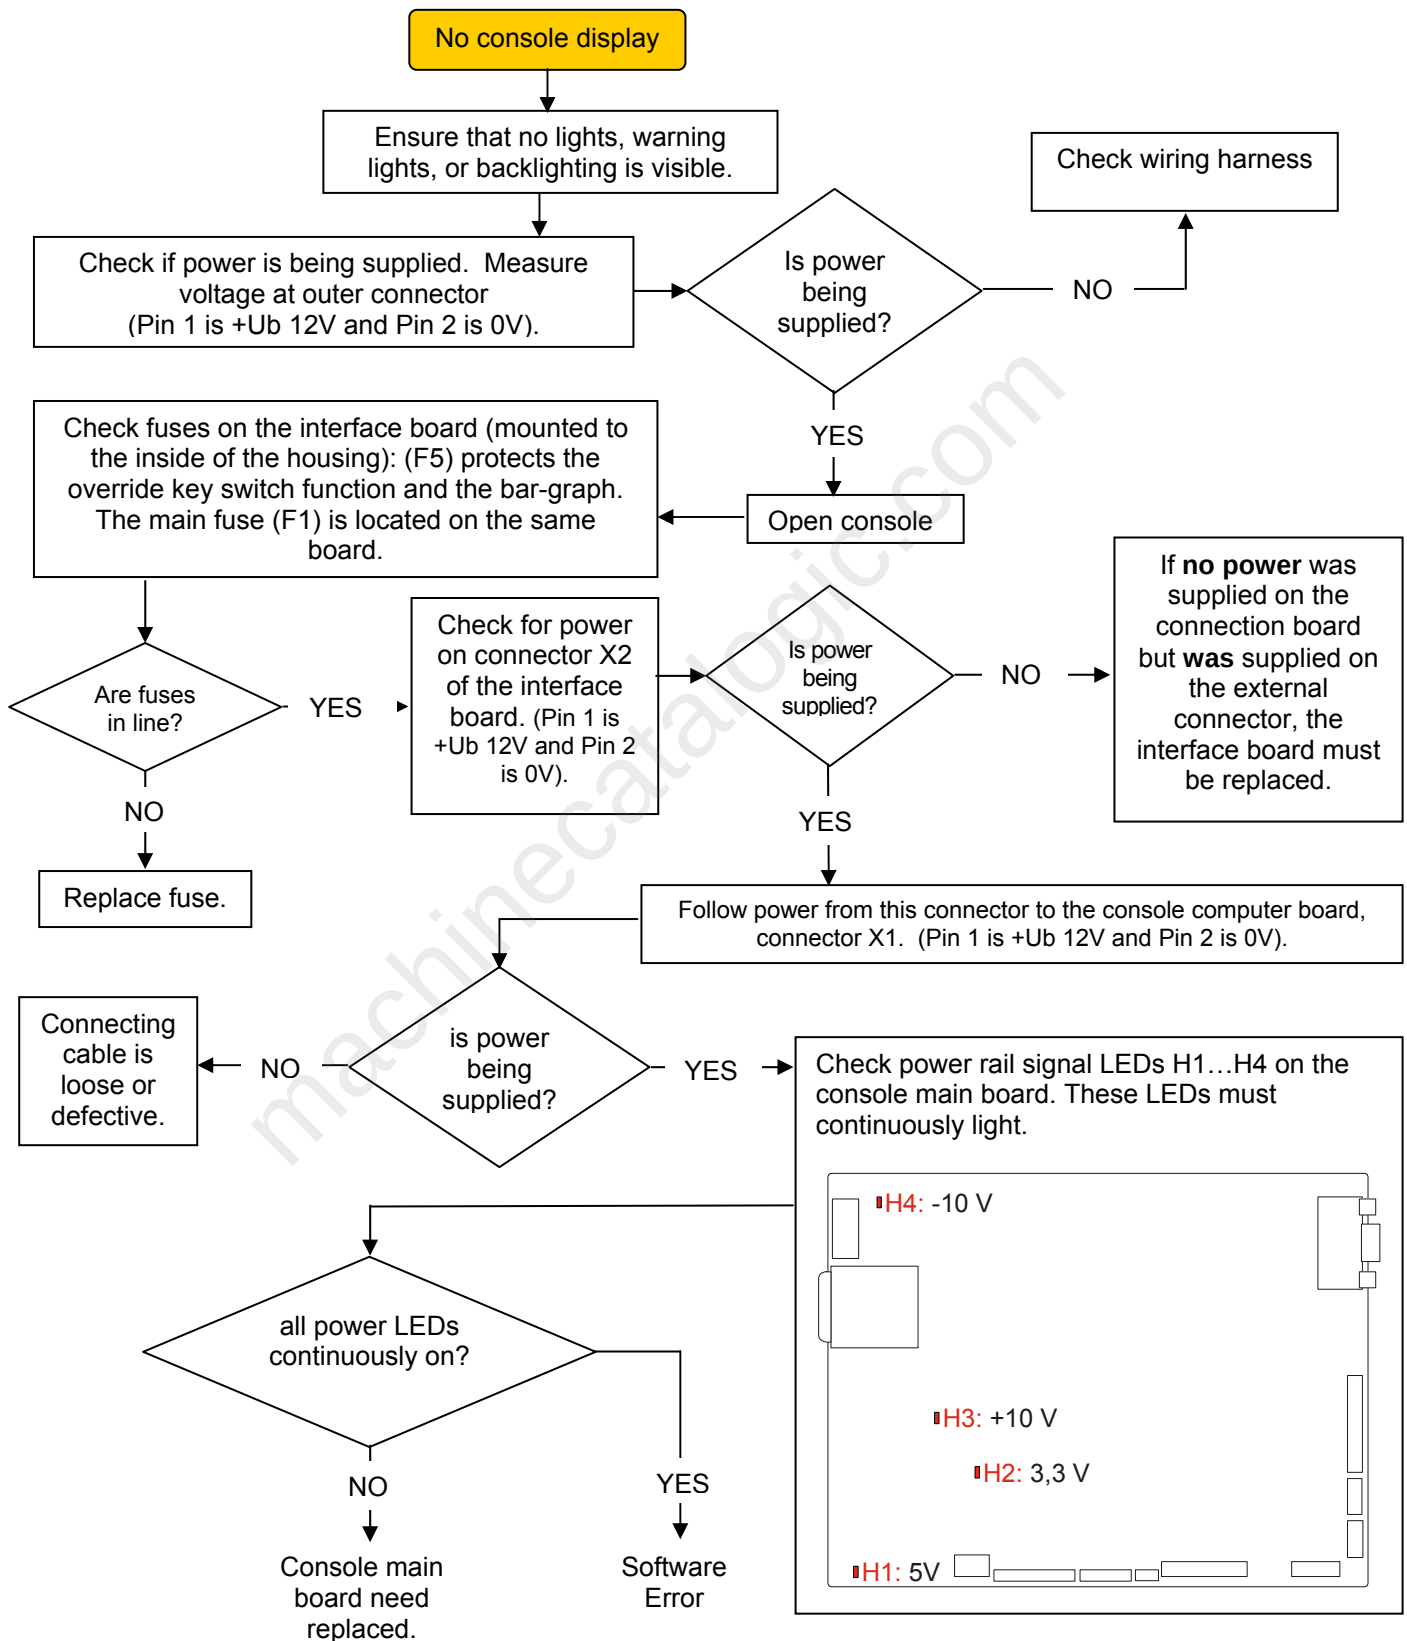
## 10 NO CONSOLE DISPLAY

If the console is not showing any lights, such as warning lights, backlighting, etc. it is most likely missing power. Start with the following:

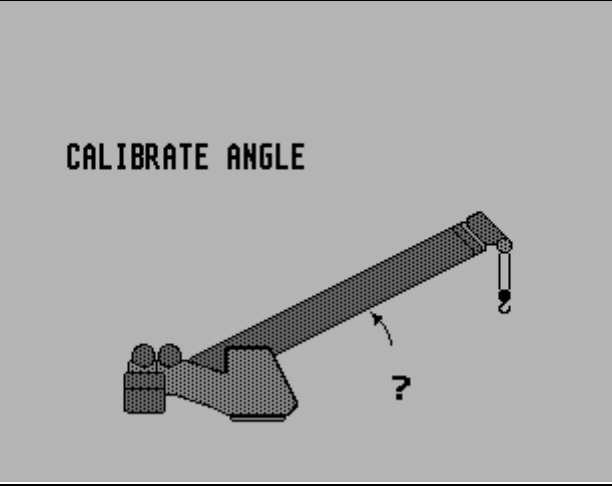
▼ Calibration screen (boom angle)

| | | skip calibration step |
| | | <b>start angle calibration procedure</b> |
| | | cancel and return to LMI screen |

15.5 ANGLE SENSOR CALIBRATION PROCEDURE

The angle sensor can be calibrated for its zero point and with steep boom

- Select Angle sensor calibration menu and start procedure by pressing "OK"

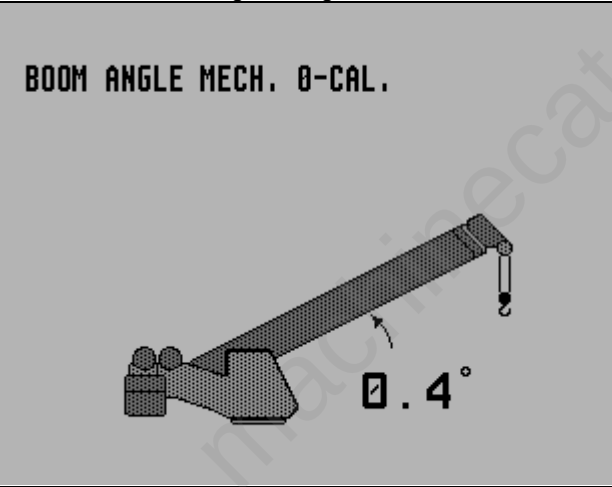
▼ Start calibration for "zero degree" angle

| | | skip calibration step |
| | | calibrate next angle |
| | | cancel and return to LMI screen |
