WORKSHOP MANUAL

G23, G26

**Kubota**

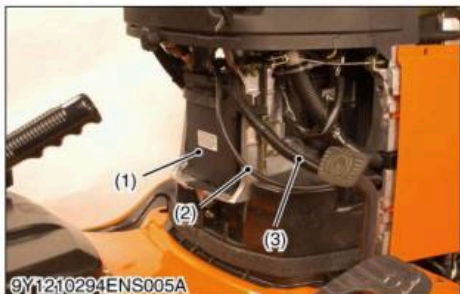
### Battery Cables and Battery

1. Remove the under panel.
2. Disconnect the negative cable (2) from the battery (1).
3. Disconnect the positive cable (3) from the battery (1) and remove the battery (1).

| (1) Battery | (3) Positive Cable |
| (2) Negative Cable | |

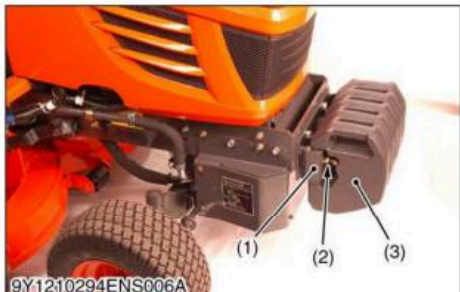
### Removing Front Weight

1. Loosen the front weight mounting bolts (2).
2. Remove the front weight (3).
3. Remove the front weight bracket (1).
4. Remove the hydraulic hose cover (4).

| (1) Front Weight Bolt | (3) Front Weight |
| (2) Front Weight Bolt | (4) Hydraulic Hose Cover |

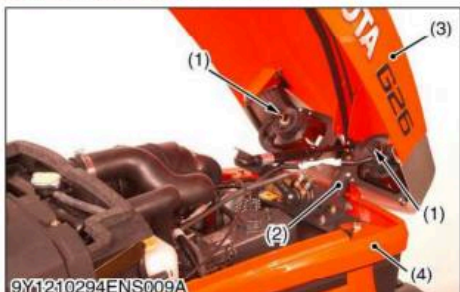
### Bonnet and Under Cover

1. Open the bonnet (3) and then loosen the knob bolts and pull forward to remove the under cover (4).
2. Disconnect the connectors (1) for head light and remove the bonnet bracket (2) with bonnet.

| (1) Connector | (3) Bonnet |
| (2) Bonnet Bracket | (4) Under Cover |

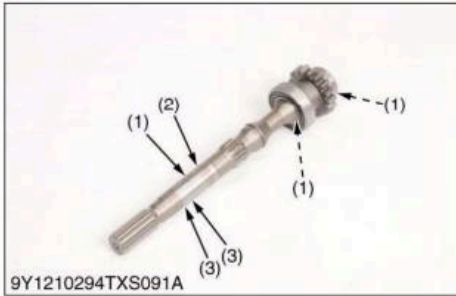
**HST Pump Shaft**

1. Check the seal surface (2), the bearing surface (1), and the O-ring surface (3).
2. If the pump shaft is rough or grooved, replace it.
3. If the ball bearing or the needle bearing is worn, replace it.

| (1) Bearing Surface | (3) O-ring Surface |
| (2) Seal Surface | |

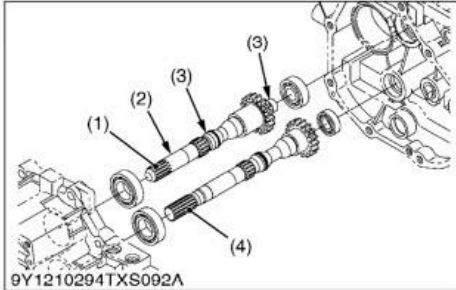
**HST Motor Shaft**

1. Check the seal surface (2) and the bearing surface (3).
2. If the motor shaft (1) is rough or grooved, replace it.
3. If the ball bearing or needle bearing is worn, replace it.

| (1) HST Motor Shaft | (3) Bearing Surface |
| (2) Seal Surface | (4) HST Pump Shaft |

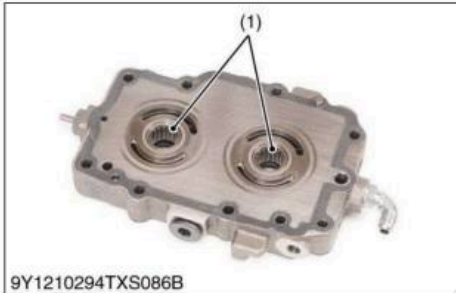
**Needle Bearing**

1. Check the needle bearing (1) for wear.
2. If the needle bearing (1) is worn, replace it.

| (1) Needle Bearing |

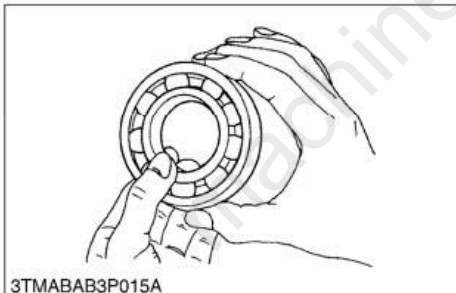
**Bearing**

1. Hold the inner race, and push and pull the outer race in all directions to check wear and roughness.
2. Apply the transmission oil to the bearing, and hold the inner race. And turn the outer race to check rotation.
3. If there are any defect, replace the bearing.
