WORKSHOP MANUAL  
**TRACTOR**

**L2800 L3400**

**Kubota**

### Governor Springs and Speed Control Plate

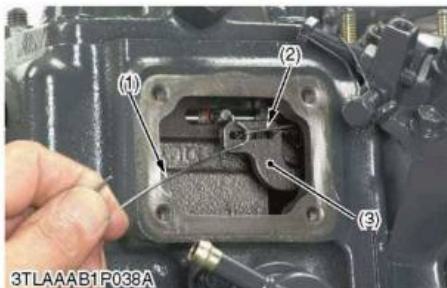
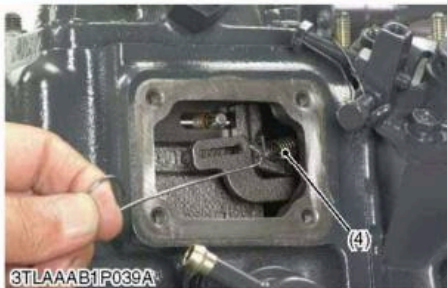
1. Remove the injection pump cover.
2. Remove the speed control plate mounting nuts and bolts.
3. Using the specific tool (1), undo the large governor spring (2) from the fork lever (3).
4. Using the specific tool, undo the small governor spring (4) from the fork lever (3).
5. Set the speed control lever (5) as the photo.
6. Take out the speed control plate (6) with care not to let the large and small governor springs come off this plate and fall into the gear case.
