WORKSHOP MANUAL
TRACTOR

**L3240, L3540, L4240,
L5240, L5740**

Kubota

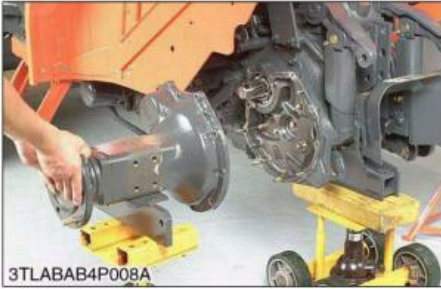
3TLABAB4P008A

1. Remove the cabin mount bracket (1).

Tightening torque	Cabin mount bracket mounting screw	167 to 196 N·m 17.0 to 20.0 kgf·m 123 to 144 lbf·ft
-------------------	------------------------------------	---

(1) Cabin Mount Bracket

(2) Screw (M14 × 30)
